XVI. ACCESSIBILITY

STANDARDS AND FINDINGS

C. FINDINGS

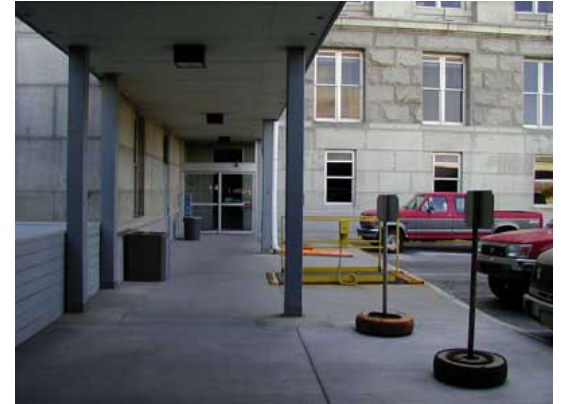
NORTH ENTRANCE

The three parallel parking spaces marked accessible located at the Northwest Entrance do not meet any accessible parking space design.

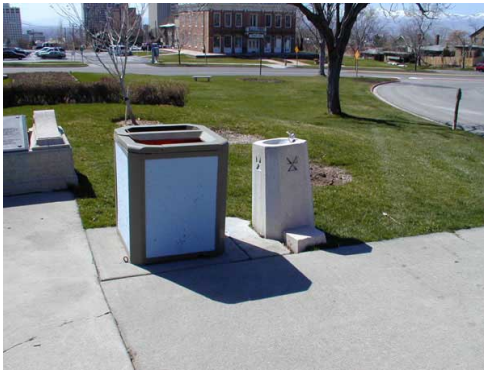
DRINKING FOUNTAIN AT MORMON BATTALION

There is currently no accessible parking near this monument. The slope of the driveway is too steep for a wheelchair to safely access the monument from Parking

Lot C. The monument consists of five levels. Only the first level is accessible by wheelchair.

Making the Mormon Battalion Monument fully accessible will require very clever solutions to avoid negative impacts to this National Register-listed feature.

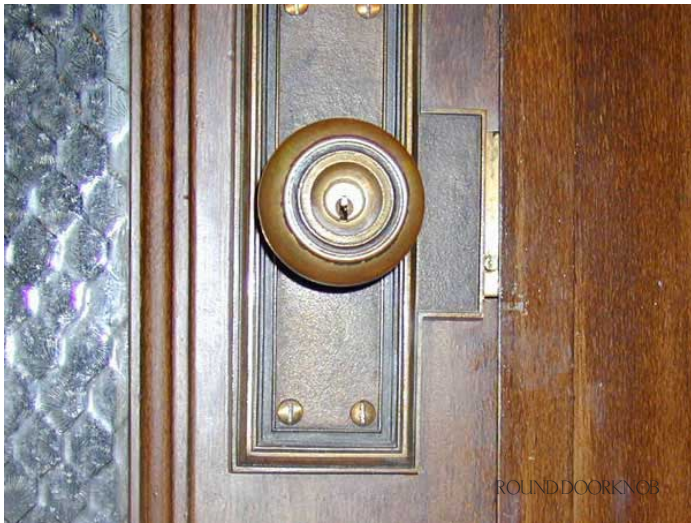
Due to the extensive structural, mechanical and electrical work planned for Capitol's interior detailed reviews of the restrooms were not done. However, the following general deficiencies found were:

- Incorrect signs
- Doors too heavy
- Insufficient pull or push side clearance at entrance or interior doors
- Lavatory pipes not wrapped
- Intended accessible stalls too small
- Round lavatory hardware
- Paper towel dispensers, mirrors, mounted too high or too hard to use
- Insufficient maneuvering space

If the state decides not to complete the planned work in the restrooms, a more detailed evaluation can be done.

6. Directional signs with the location of the nearest TTY must be mounted at each phone bank.
7. As mentioned earlier, a detailed review of the restrooms was not done. There are many access issues in all restrooms that must be considered. **Since there are numerous access issues with all the restrooms in the Capitol, it is recommended that all restrooms be demolished and rebuilt to meet ADA requirements.**

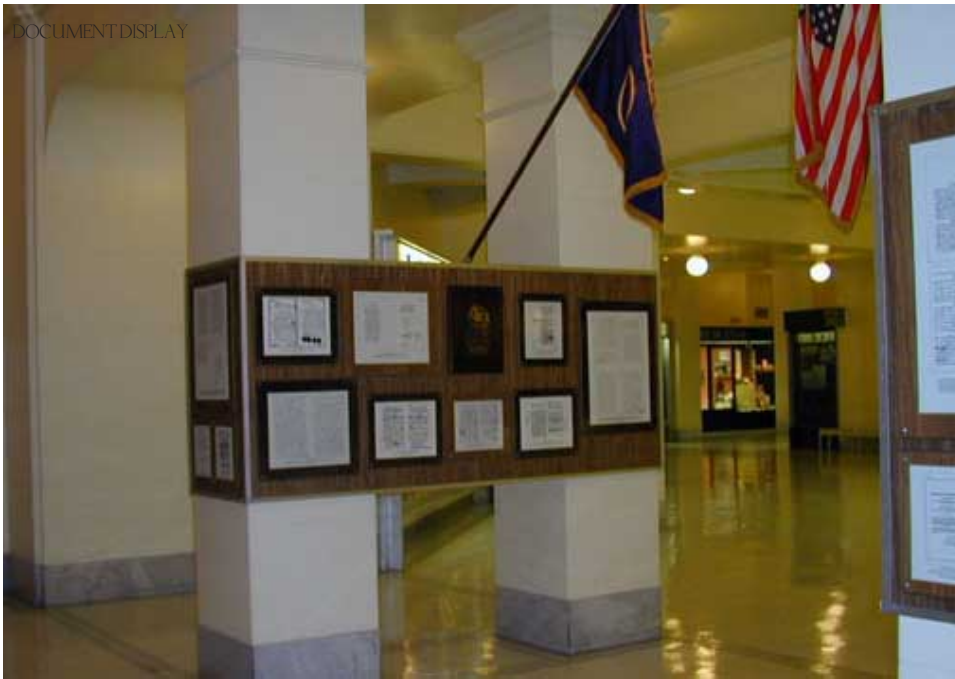
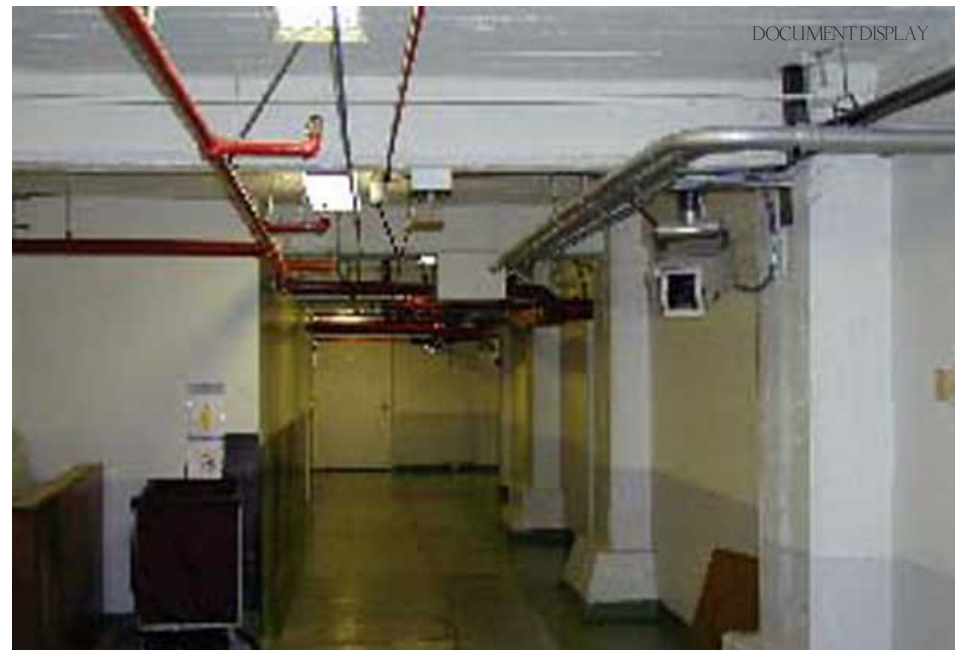
Low hung pipes along the ceiling of the basement are protruding objects. In addition, round doorknobs were being used on at least 12 doors. Restrooms have many of the same issues as restrooms on the other floors.
